**FINAL CONTRACT REPORT**

**GILES COUNTY, VA  
PEDESTRIAN BRIDGE COLLAPSE &  
FAILURE ANALYSIS**

*Project Manager*  
Jose Gomez, Virginia Transportation Research Council

Virginia Transportation Research Council  
(A partnership of the Virginia Department of Transportation  
and the University of Virginia since 1948)

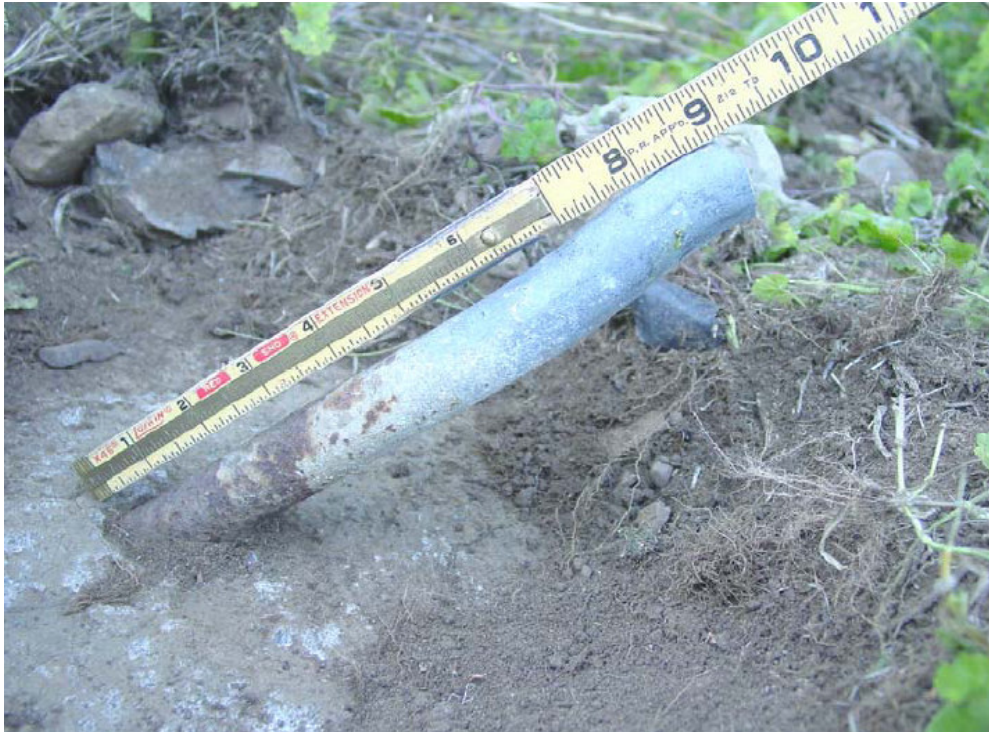
**Figure 6. Fractured Anchor Rod**

Figure 6 shows the fractured anchor rod shortly after the bridge collapse. Figure 7 shows a close-up view of the fractured surface of the anchor rod. The rod appears to have fractured at the widest point of the hook. VDOT crews searched for the missing portion of the hook, but it could not be located. The rod was saw cut as close to the concrete dead-man as possible so the specimen could be analyzed. The bar was sent to Dr. Bill Wright of the FHWA.

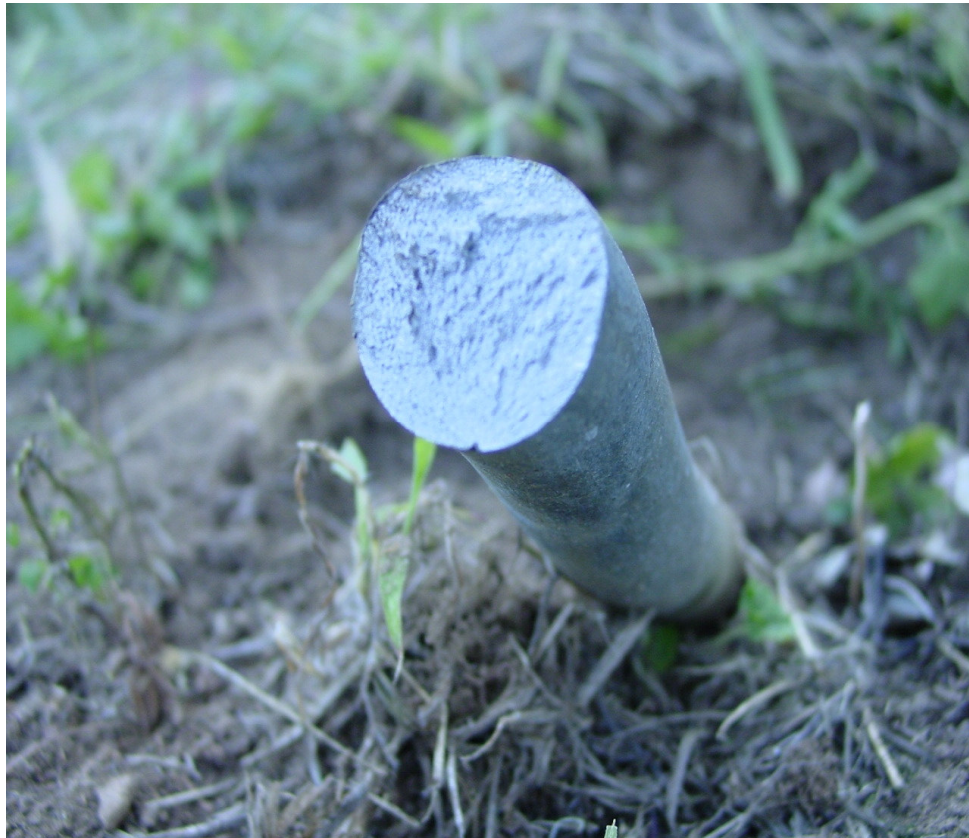
**Figure 7. Cross section view of fractured anchor rod**

The other important conclusion came from microscopic investigations. There was a small defect at the fractured surface (Figure 7 shows this defect located at the surface of the lower edge of the rod). This flaw is likely to have triggered the brittle failure of the rod. However, fracture appears to have been preceded by yielding at the inside of the hook.

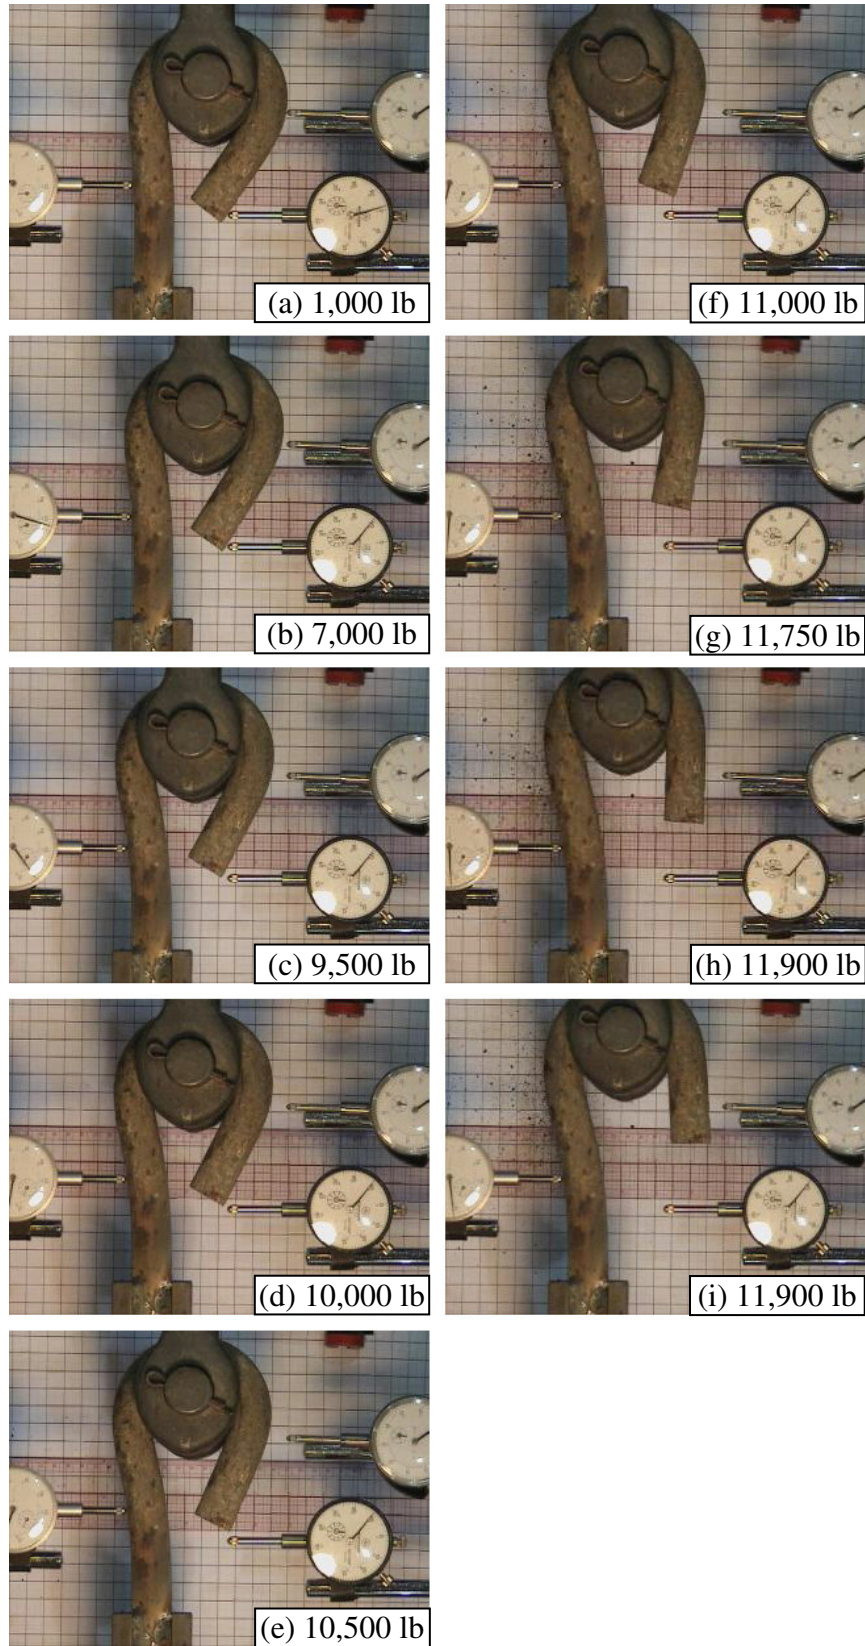
**Figure 14. Frames from Testing Video and Corresponding Load**

Figure 14 displays how the anchor rod hook deformed as the load was increased with frames from the video corresponding to selected loads. The frame pictures highlight the overall behavior of the hook as tension and the corresponding induced moment are applied to the specimen. Figure 14 (a) is a frame from the beginning of the test with all of the dial gage instrumentation recording deformation values. A close look at the graph paper in Figure 14 (a) shows the gap at the end of the hook is approximately  $\frac{1}{2}$  in. Figure 14 (b) shows dial gage 3 is no longer touching the anchor rod; this is due to the fact that the anchor rod is straightening and starting to un-hook. This effect is evident both in Figure 14 (c) and in Figure 15. In Figure 14 (c) dial gage 2 is no longer touching the hook, and in Figure 15 the displacement measured by both dial gage 2 and dial gage 3 are vertical lines indicating they are no longer in contact with the anchor rod hook. Also evident in Figure 15 is that the dial gages stopped measuring displacement prior to a load of 7,000 lb as is indicated in Figure 14. The plotted values of dial gage displacement show dial gage 2 stopped measuring displacement at approximately 4,000 lb and dial gage 3 stopped measuring displacement at approximately 1,000 lb.

From Figure 14 (d) through (i), 10,000 lb through the final load of 11,900 lb, it is evident that the hook of the anchor rod is opening and attempting to straighten. Figure 14 (h) and (i) are both video camera frames at a load of approximately 11,900 lb. During the time period between these two frames, the hydraulic ram was still pulling the anchor rod in tension and opening the specimen's hook, but the load was no longer increasing beyond the maximum load shown in Figure 13. The investigators believe that this is the ultimate behavior of the anchor rod and hook over time. Any attempt to add additional load would lead to more deformation in the anchor rod hook (a straightening or opening behavior). Figure 14 (i) and Figure 16 show that the final gap between the shaft of the anchor rod and the hook, measured with the graph paper, is approximately 2 in. Additionally, Figure 17 shows the typical behavior of the anchor rod as it is attempting to straighten. The final eccentricity of the line of action from the turnbuckle to the anchor rod shaft was measured to be approximately  $\frac{3}{4}$  in. as compared to the original eccentricity of approximately  $1\frac{1}{2}$  in. shown in Figure 14 (a). However, the maximum eccentricity is still  $1\frac{1}{2}$  in., measured from the centerline of the turnbuckle pin to the center of the bar at the widest point of the hook.

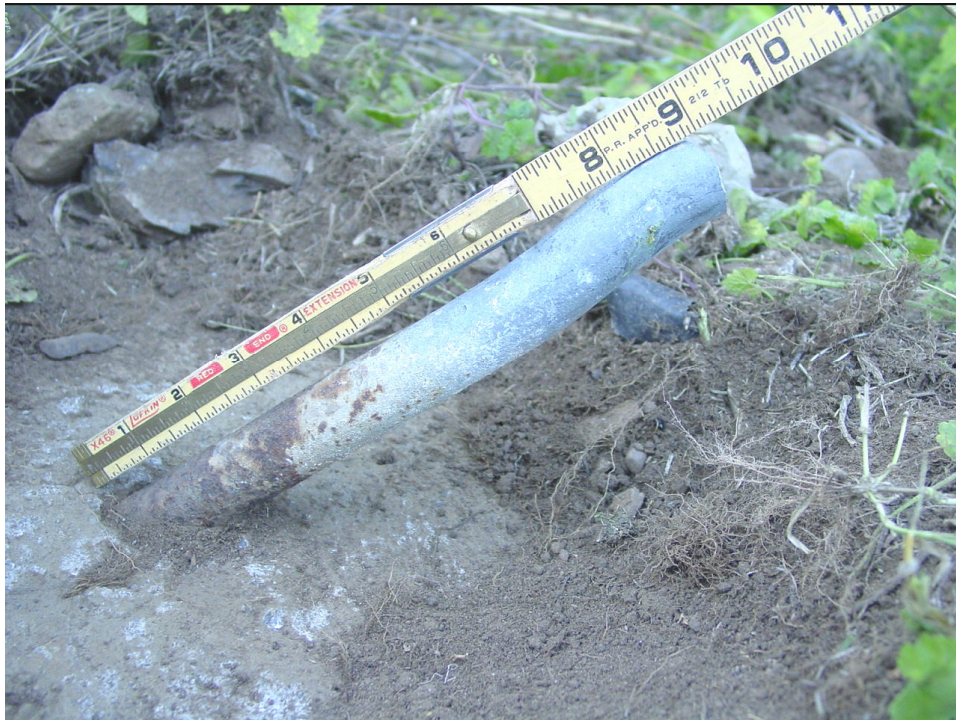
This report presents results of failure analysis testing that was performed on a failed anchor rod from a pedestrian bridge in Giles County, Virginia. Figure 1 shows the failed anchor rod before it was removed and sent to the Turner-Fairbank Highway Research Center (TFHRC). The hook portion of the anchor rod was not recovered and could not be examined.

**Figure 1 Failed anchor rod in-situ prior to removal for laboratory examination and testing.**

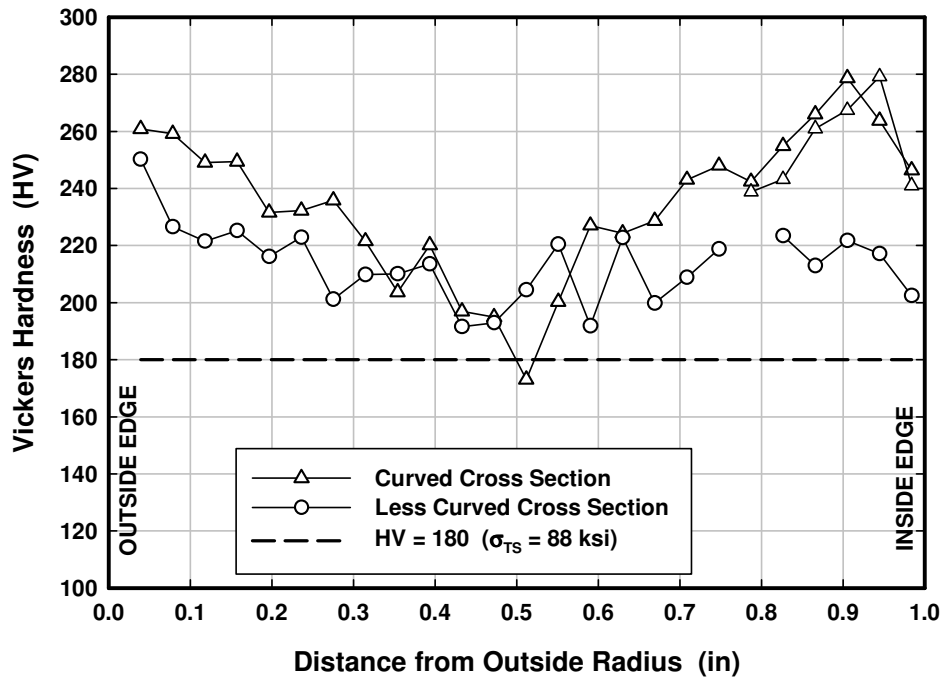
Figure 7 shows the variation in Vickers hardness across the rod at two cross-sections. Some replicate tests were performed at the curved cross section near the inside edge to verify the peak hardness readings. Tests were performed at 1 mm intervals across the surface, starting 1 mm away from the interface between steel and the galvanized layer. For comparison, the dashed line shows the hardness that would be expected for a steel with 88 ksi tensile strength according to the ASTM A 370 specification. The hardness measurements near the center correlate well with the tension test results. There is a definite increase in hardness toward both surfaces of the rod. The highest hardness is observed close to the inside edge (inner radius) at the cross section with maximum curvature near the fracture location. The Vickers hardness of 279 approximately correlates to a tensile strength of 128 ksi, a 45 % increase relative to the center of the anchor rod.

Figure 7 Hardness profile through the center of the rod in the bending plane of the hook.

While the reason for the increased hardness is not precisely known, the pattern suggests strain aging as a possible cause. The curved cross section shows higher surface hardness compared to the less curved section. It also shows more hardening occurs on the inside of the bending radius where the highest strain occurs in bending of curved beams. Strain aging typically increases both the yield and tensile strength by similar amounts. Therefore, it is reasonable to assume a 45% increase in yield strength at the surface, increasing the surface yield stress to  $54.2 \times 1.45 = 78.6$  ksi.

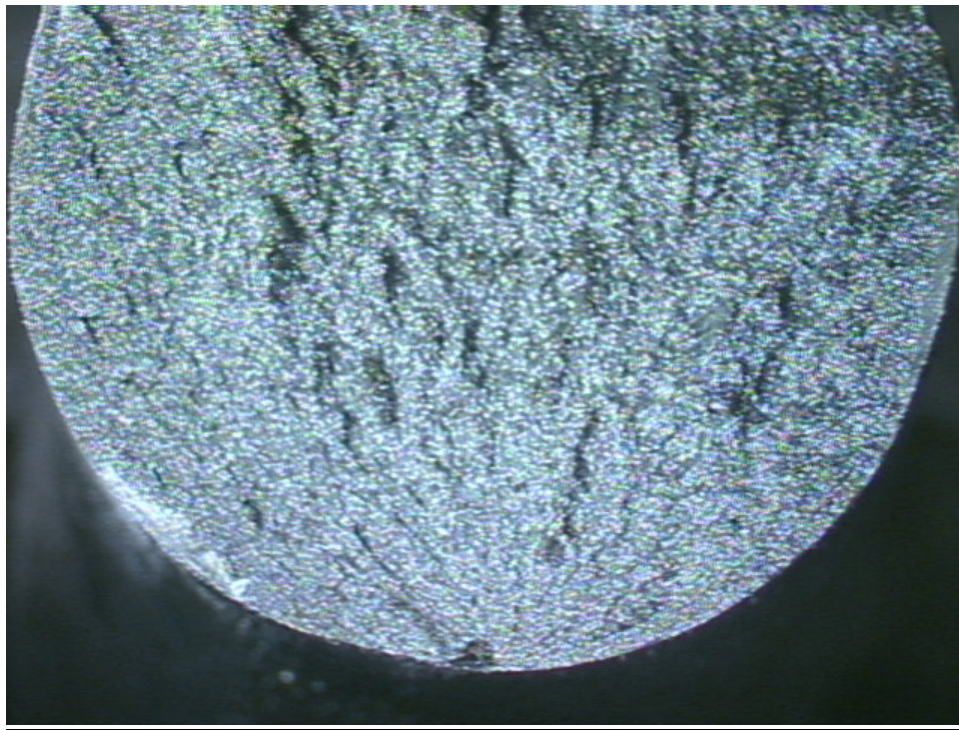
Initial examination revealed a small semi-circular defect originating at the surface of the anchor rod along the inside of the bend radius. Figure 8 shows the presence of chevron lines on the fracture surface radiating away from the defect. This is typical in brittle fracture and the chevron lines point to the defect as the fracture initiation site.

**Figure 8** Fracture surface showing chevron lines radiating from a small flaw at the bottom of the photo.

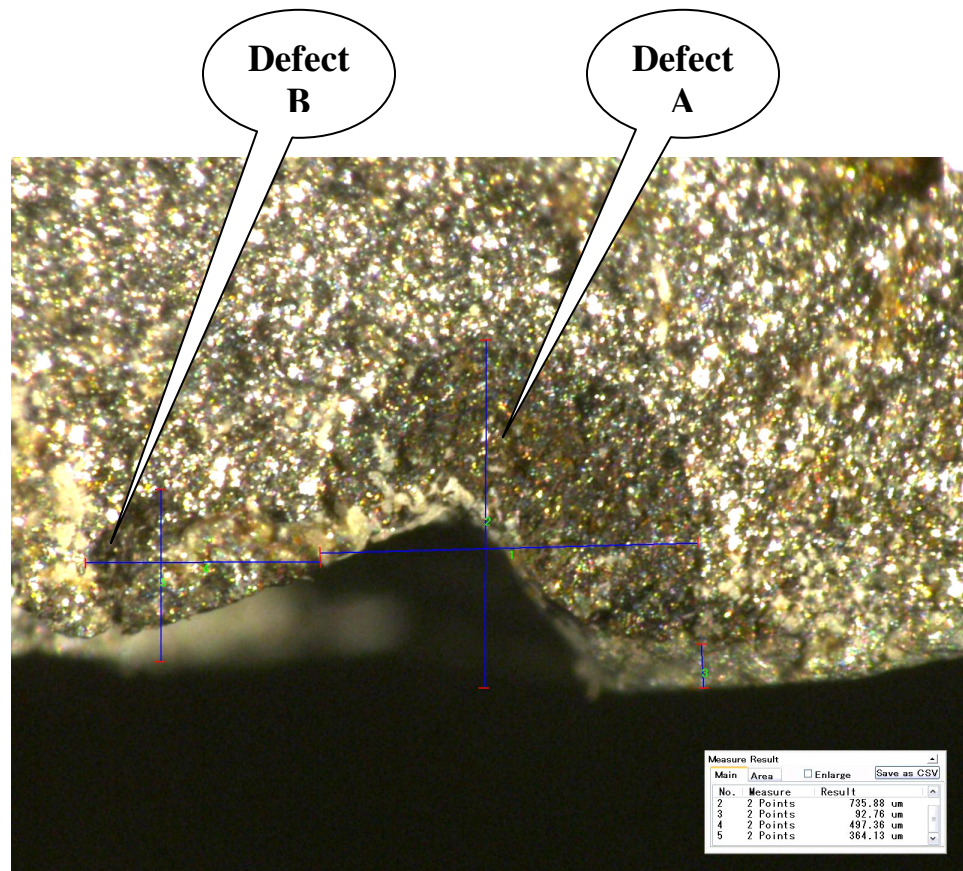
Figure 9 shows a close-up view of the defect looking at the fracture surface. A 15 mil deep corrosion pit is present on the surface of the rod that appears to have developed underneath the galvanized coating. There are two darker semi-circular crack-like defects that appear to have initiated from the corrosion pit. The darker color indicates light surface discoloration compared to the brighter overall fracture surface. This indicates the crack-like defects existed prior to fracture of the rod. The larger semi-circular defect on the right of figure 9 (Crack "A") measures about 29 mil deep from the rod surface. The smaller defect on the left (Crack "B"), extends

about 14 mils deep. It was unclear from optical examination if the defects are separate or coalesced together. Note that the optical digital microscope used to take the images in figures 8 through 11 inverts the image compared to the SEM images in the following section.

**Figure 9 Close-up view of the crack-like defect originating from the corrosion pit. (150X)**

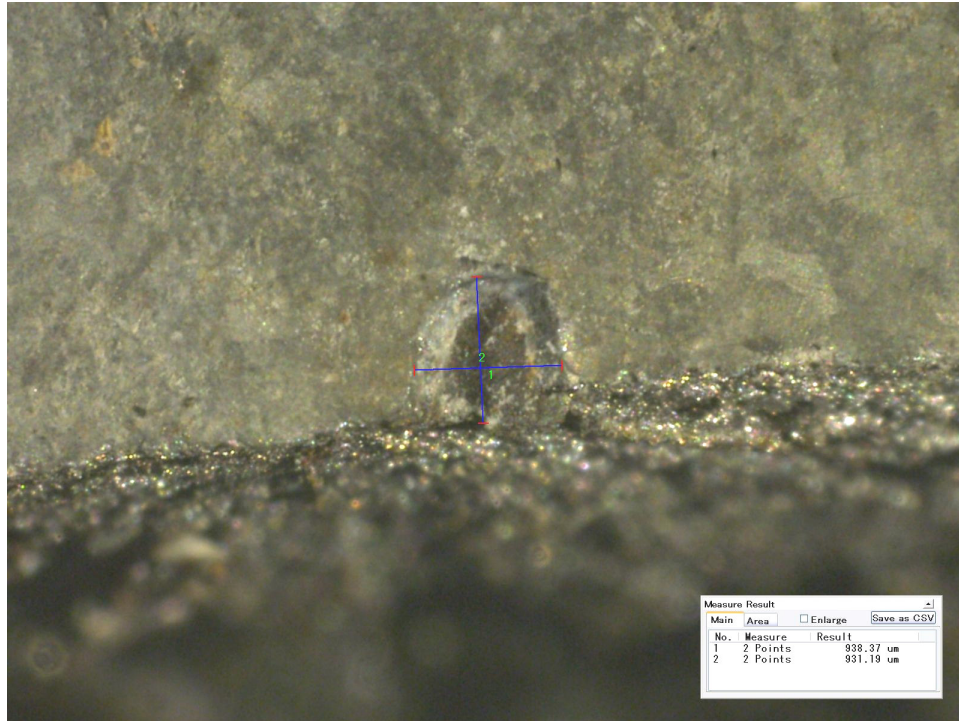
Figure 10 shows the galvanized surface of the anchor rod at the edge of the fracture. A corrosion pit measuring about 0.037 in. is apparent on the surface of the rod. The dark center region is a deep brown color indicating corrosion on the steel surface. The lighter ring around the center is a conical break through the thickness of the galvanized coating. The conical surface area is much brighter than the galvanized surface of the rod, indicating that this surface is newer and has been exposed to less weathering. It is likely that a corrosion cell developed under the surface of the galvanized coating and eventually created pressure that caused a conical break through the surface. It cannot be determined if this surface break existed prior to the fracture of the rod or occurred during the fracture.

**Figure 10 Surface of the hook rod showing a corrosion pit with diameter about 0.037 in. (50X)**

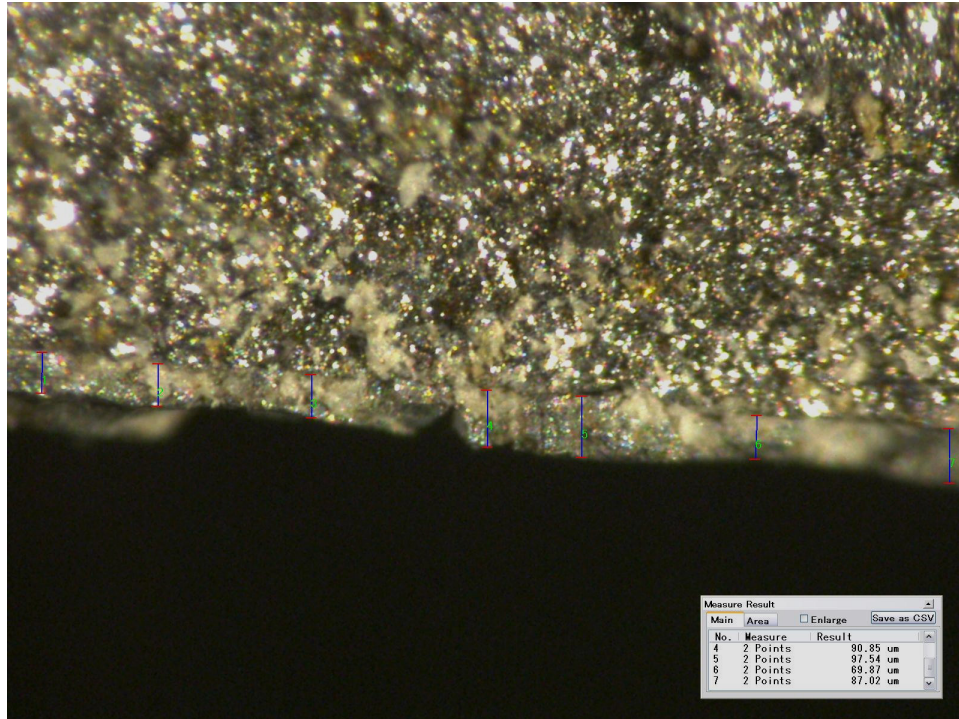
Figure 11 shows a view of the fracture surface adjacent to the defect showing the galvanized coating. There is some local variability in thickness, but on average the galvanized coating is about 3.5 mils thick. Figure 12 shows the surface of the anchor rod along the inside of the bend radius. The fracture surface is to the left of the figure. A series of short transverse cracks appear to be present on the galvanized surface. There is some minor evidence of rust bleeding around some of the surface cracks, indicating the possible presence of sub-surface corrosion. These cracks were only apparent on the inside bend radius. There was no evidence of cracking along the outside bend radius or along the sides of the anchor rod.

**Figure 11** Measurements of the galvanized coating thickness adjacent to the crack-like defect indicating about a 3.4 mil average thickness. (150X)

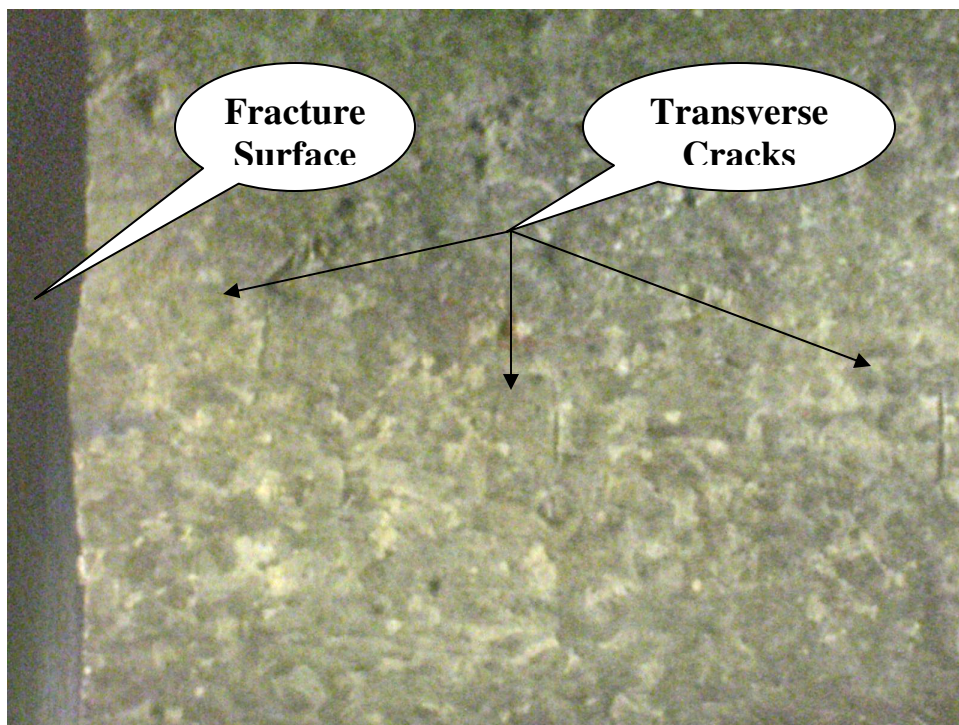
**Figure 12** Surface of the anchor rod along the inside of the bend radius showing a number of small transverse cracks on the galvanized surface. (20X)

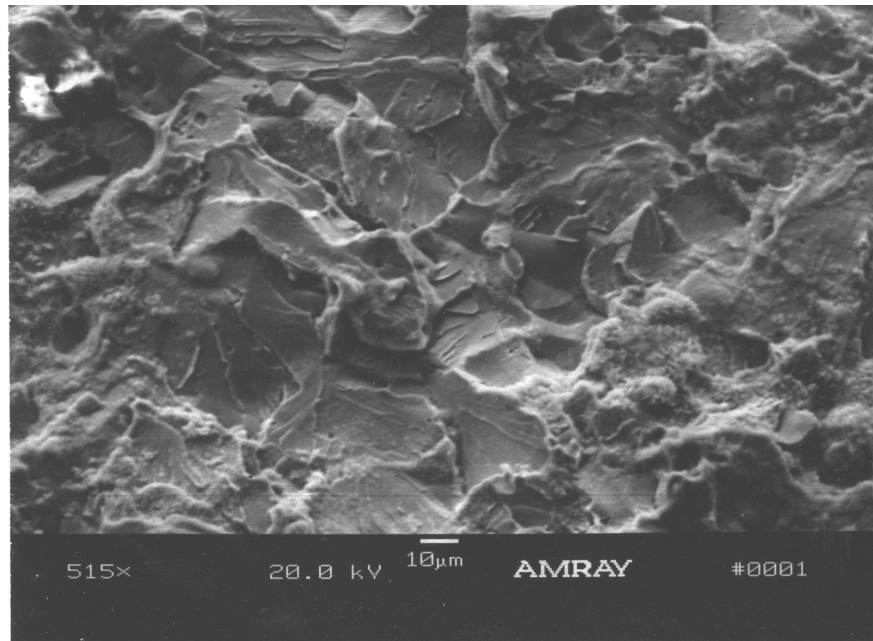
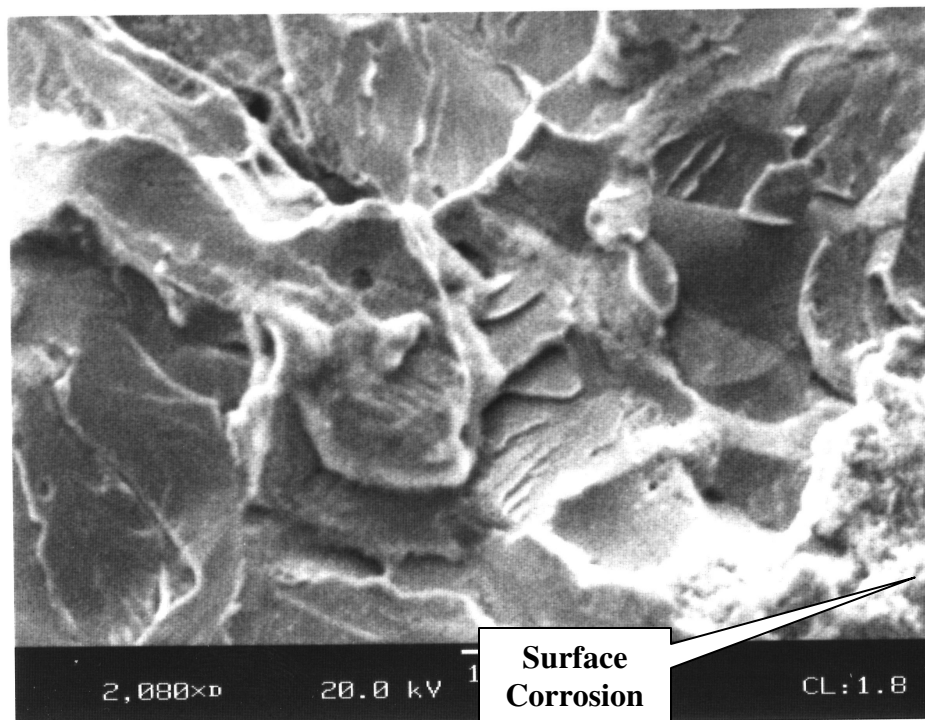
Figures 14 and 15 show the fracture surface at location A-2 in the middle portion of defect A. The surface appears to have a combination of inter-granular and trans-granular cleavage cracking. In some locations, there is evidence of inter-granular cracks extending into the material from the crack surface. There is also evidence of corrosion on the crack surface at random locations. No evidence of fatigue striations could be found on the surface. Cyclic loading could have contributed to the gradual propagation of inter-granular cracking (corrosion fatigue) but fatigue does not appear to be the primary cause of cracking.

**Figure 14** Location A-2 showing a combination of inter-granular fracture and trans-granular cleavage.

**Figure 15** Location A-2 showing area of surface corrosion.

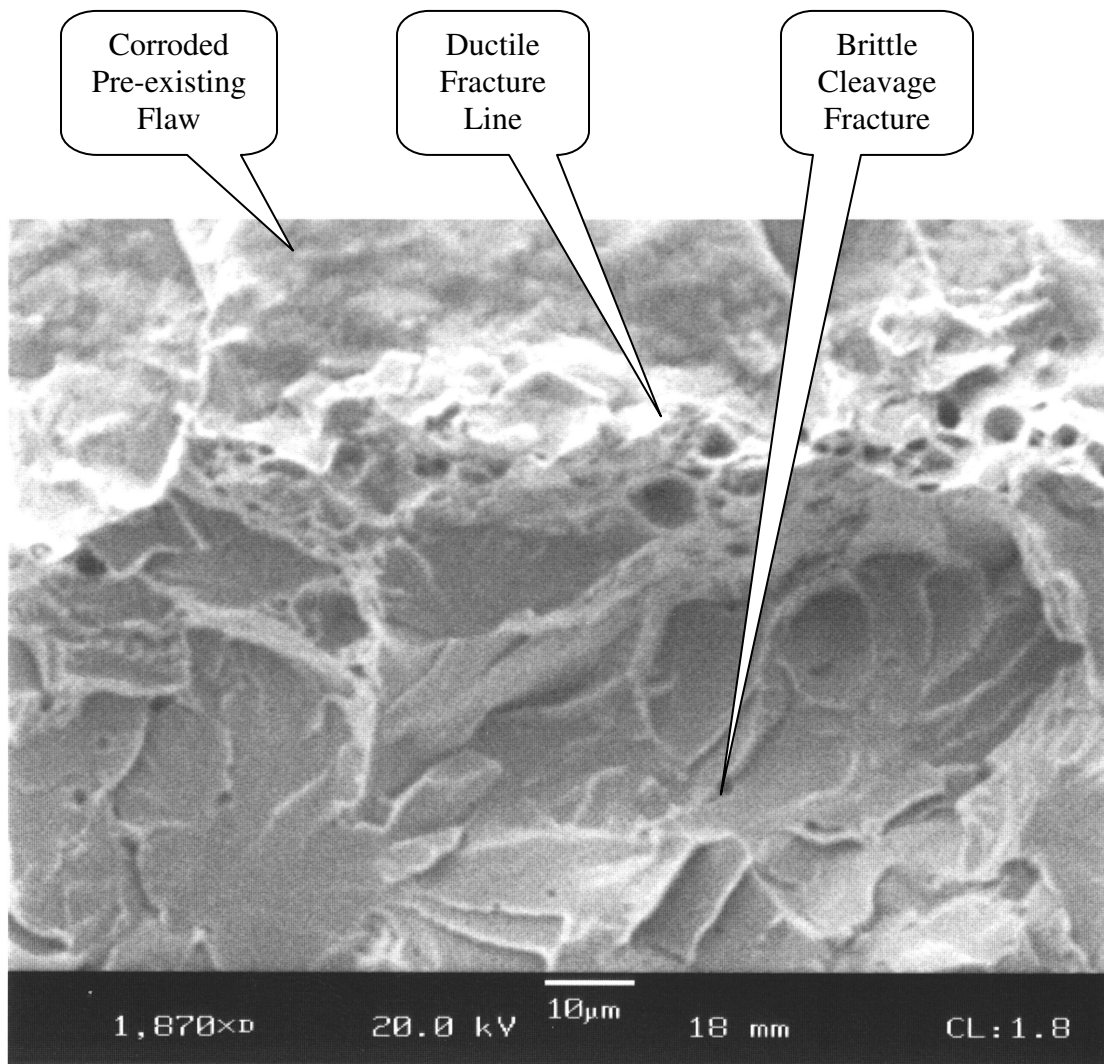
Figure 16 shows the semi-circular boundary of the crack-like defect at location A-3. A distinct area of ductile fracture is evident around the circular boundary of the defect. The conical dimples are typical for material that fails by micro-void coalescence with significant plastic deformation prior to fracture. The area below the circular boundary is brittle trans-granular cleavage fracture. This is typical for the entire fracture surface outside of the circular boundary. There is no corrosion evident on the fracture surface outside of defect A indicating it was not exposed for long to the environment.

**Figure 16 Location A-3 showing ductile fracture at the transition between the preexisting defect and the brittle fracture surface.**

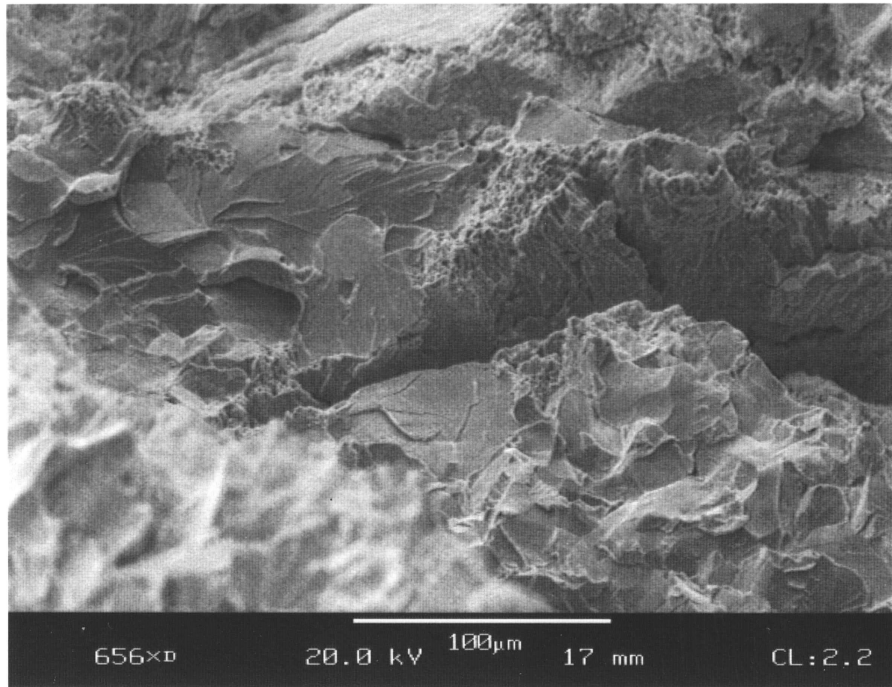
**Figure 17 Inter-granular cracking at location B1**

Figure 17 shows an area close to the surface of the anchor rod in defect B. In general, defect B seemed to have more pronounced inter-granular cracking and the areas of corrosion seemed to concentrate around the inter-granular cracks. This suggests that random inter-granular cracking preceded formation of the semi-circular crack-like defect.

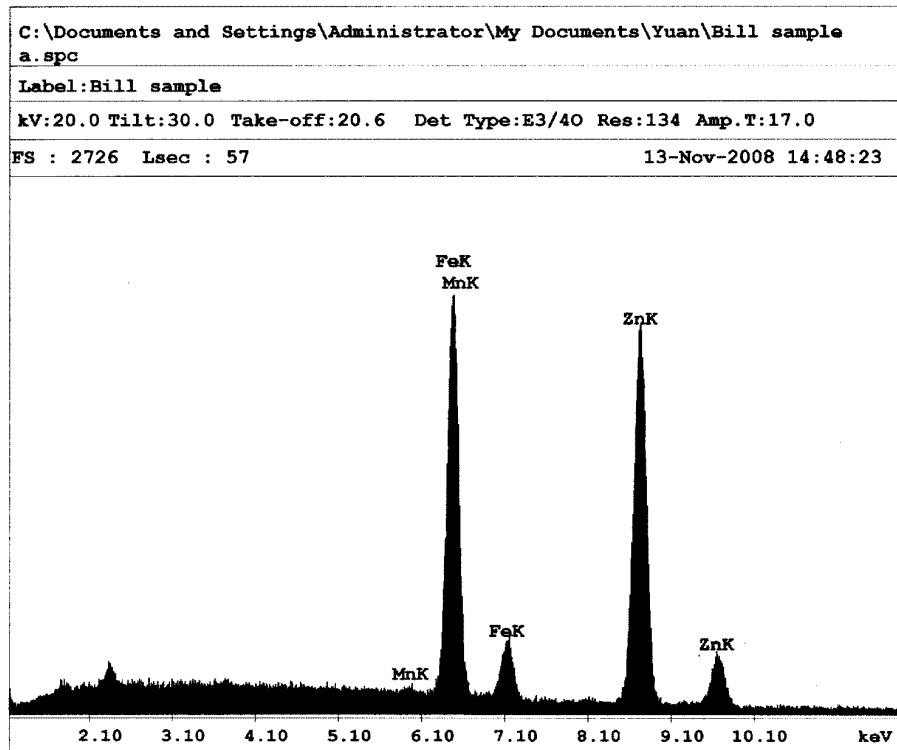
Figure 18 EDAX elemental analysis of surface of the inter-granular crack shown in figure 17.

Figure 18 shows results from an X-ray diffraction (EDAX) elemental analysis of the surface inside the inter-granular crack. As expected, the results indicate the presence of iron and manganese. However, there is also a significant presence of zinc suggesting that the trans-granular crack existed prior to galvanizing. This was observed in multiple locations in defect B.
